All About Space

14 years of discoveries

Designed to last 90 days, Opportunity survived for over a decade on Mars. Here we look back on how the record-breaking rover changed the way we see the Red Planet

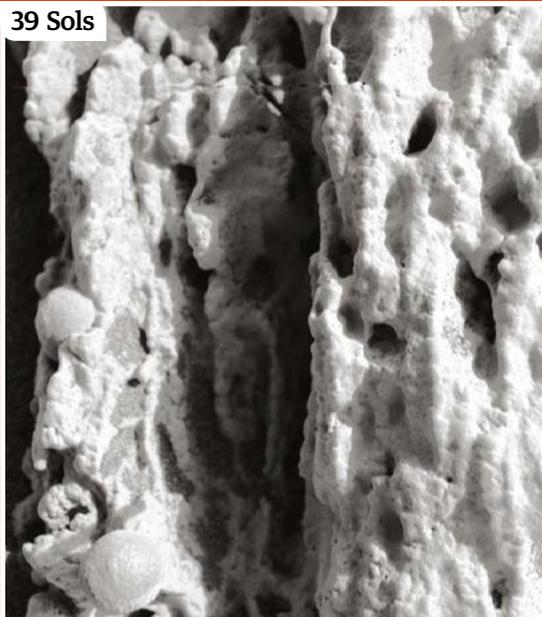
39 Sols

Signs of past water

This is a microscopic image of part of a rock called 'Last Chance'. The view here is around five centimetres (two inches) across and was taken on Opportunity's 39th Martian day. The texture of the rock has led scientists to believe that water was once present in the area in which it was found - the Meridiani Planum area of Mars, which is close to its equator.

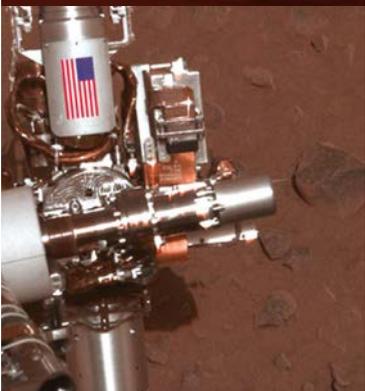
0 Sols

Made of World Trade Center metal

Part of Opportunity is made from aluminium debris salvaged from the World Trade Center, which collapsed on 11 September 2001. It was turned into a credit-card-sized sheet of metal, to which a United States flag emblem was added. That metal protects the cables that form part of Opportunity's drilling mechanism. The same is true of the Spirit rover. The team who built the part worked just six blocks away from the towers in downtown Manhattan.

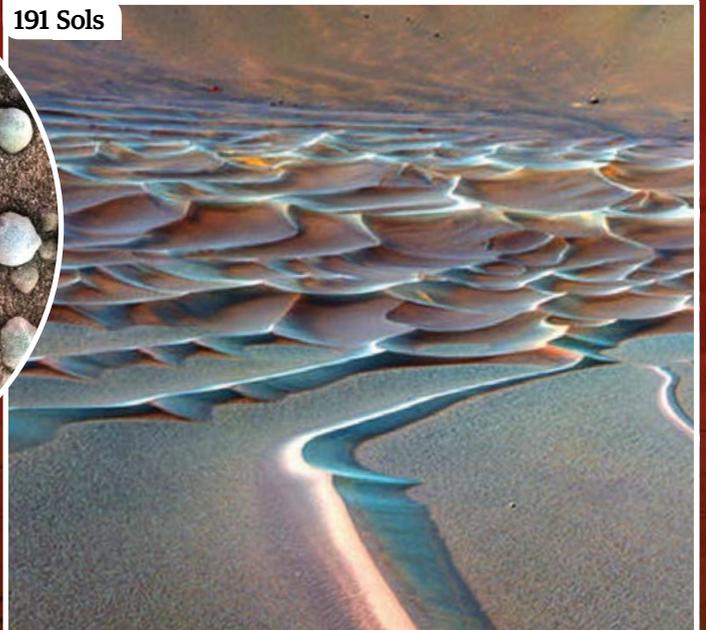
191 Sols

Sand dunes

As Opportunity entered Endurance crater it found dunes on the crater floor. Each of the ridges of sand are less than one metre (3.3 foot) high and are likely caused by the winds that whip across the dry Martian surface. Before approaching the dunes to take the photograph, the rover drivers had to assess the likelihood of Opportunity becoming marooned in the dunes. The image is in false colour and was taken by the PanCam instruments on board the rover.

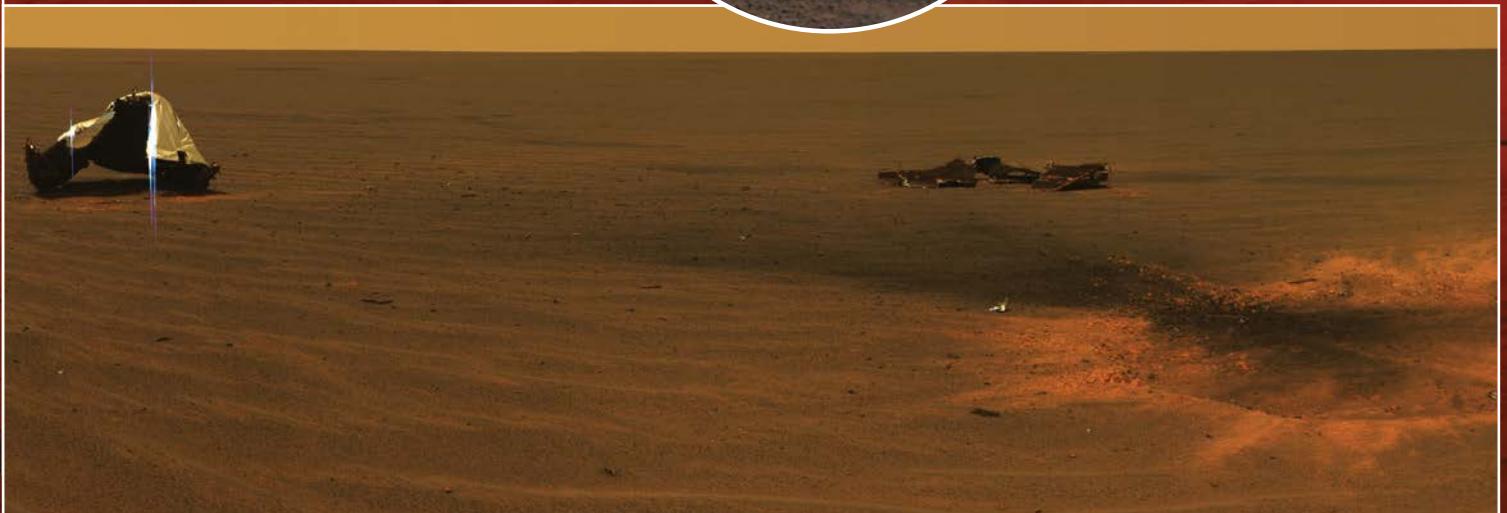
339 Sols

Meteorite find

In January 2005, Opportunity was examining the impact site of its own heat shield when it came across a meteorite on the surface of Mars. It was subsequently named Heat Shield Rock. About the size of a basketball, it was the first meteorite to be discovered on another planet (two others had previously been found on the Moon). Its iron structure meant that the abrasion tool could not be used to scratch it, as it would have been damaged.

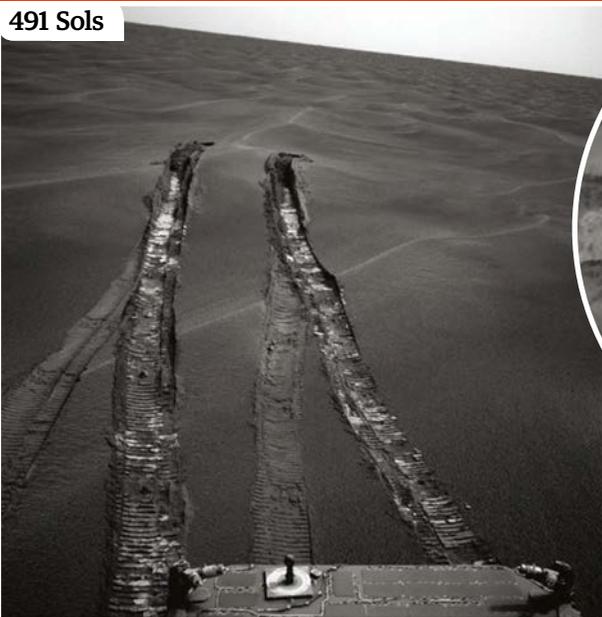
491 Sols

Stuck in Purgatory

During April 2005, Opportunity's wheels became embedded more than ten centimetres (four inches) down into some soft, sandy material. It took five weeks of planning, testing and expert driving in order to extricate the stricken rover. Due to its hellish effect on Opportunity, this region was dubbed Purgatory Dune. It could nearly have been the rover's final resting place. Luckily, it was able to escape and has continued to operate for more than a decade after its little mishap.

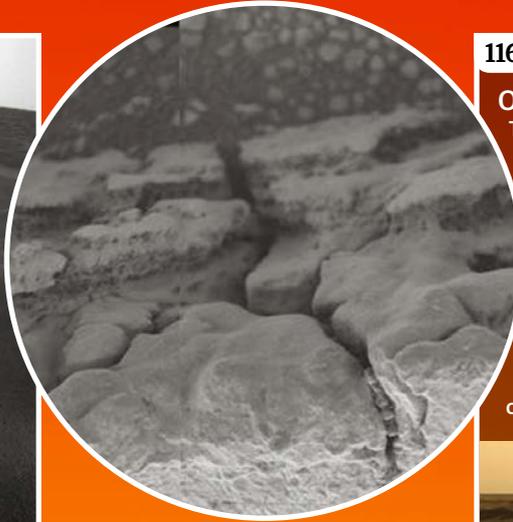
Signs of water at Roosevelt

Opportunity's microscope shows a close-up view of a structure known as Roosevelt, found near the edge of Erebus crater. Scientists have hypothesised that the fractures were caused by liquid water moving through the structure. The image is a mosaic of several smaller images all taken on Sol 727. The feature is younger than the surrounding rocks, meaning that liquid water may have been present in the area after the other sedimentary rocks had formed.

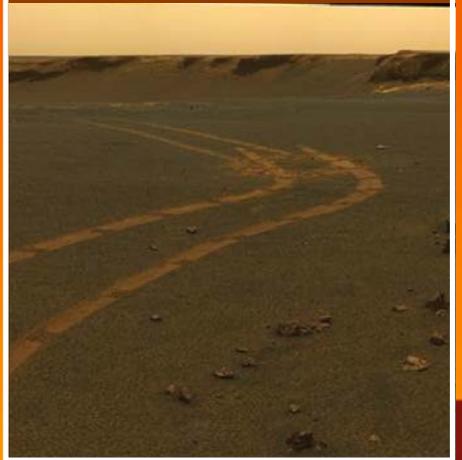
1162 Sols

Opportunity learns to drive itself

This view of Opportunity's tyre tracks was taken after it drove a curved path that was more self-determined than before. Engineers were testing out a piece of software called Field D-star, which helps Opportunity decide for itself how to get to a given destination while avoiding obstacles along the way. It was taken on Sol 1162 and Victoria crater can be seen in the background. For scale, the rocks in the centre foreground are seven to ten centimetres (2.8 to 3.9 inches) tall.

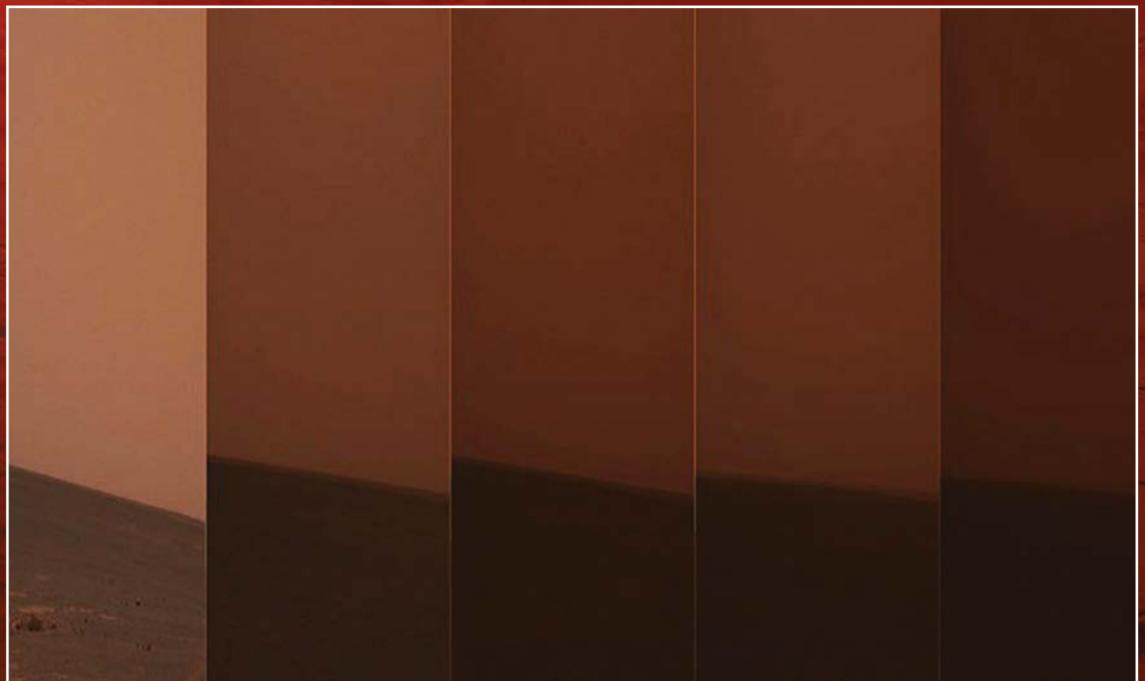
Opportunity weathers its first dust storm

In July 2007 both Opportunity and its twin rover Spirit came under severe threat from vicious dust storms whipping across the Martian surface. The rover gets its power from its array of solar panels, but the huge volume of dust brought by the storms blocked out 99 per cent of the available sunlight. Opportunity was effectively put into hibernation for a few days and the amount of contact with the rover was scaled back. Fortunately, the storms moved away and the rover survived intact.

As the dust storm gathered, the amount of daylight available to the Opportunity rover dropped dramatically. These images, taken by the rover's PanCam, shows how the sky darkened over several weeks

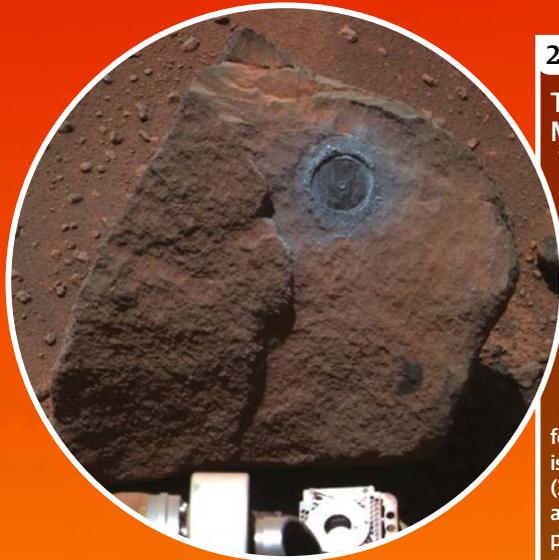
2117 Sols

Inspecting Marquette Island Rock

From November 2009 to mid-January 2010, Opportunity inspected this basketball-sized rock as NASA experts believed it might have originated deep in the Martian crust and been thrown to its present location by an impact event. The day before, the rover's abrasion tool had scratched a five-centimetre (two-inch) wide hole in the rock to help scientists learn more about its composition. It is named after an island in northern Michigan, US.

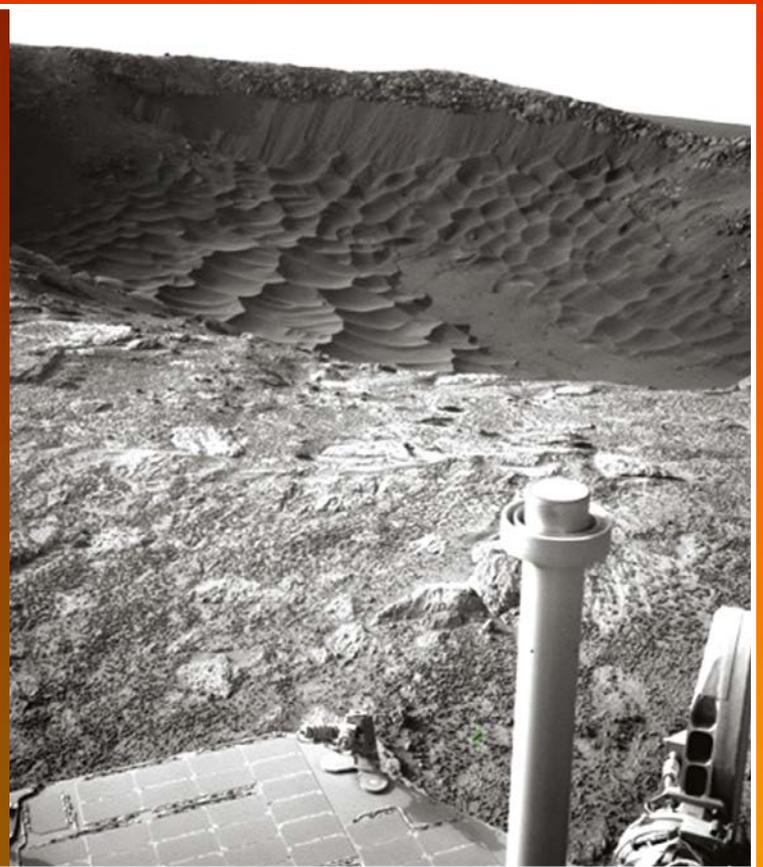
2476 Sols

Textures of Santa Maria crater

This image from Sol 2476 shows just how different areas of the same crater can appear. In the background of Santa Maria crater the material appears smooth, while it is a lot more jagged in the foreground. The crater is about 90 metres (295 feet) in diameter and the rover was perched close to the rim of the crater on its southeastern edge when this photograph was taken using the navigation cameras (hence why it is black and white).

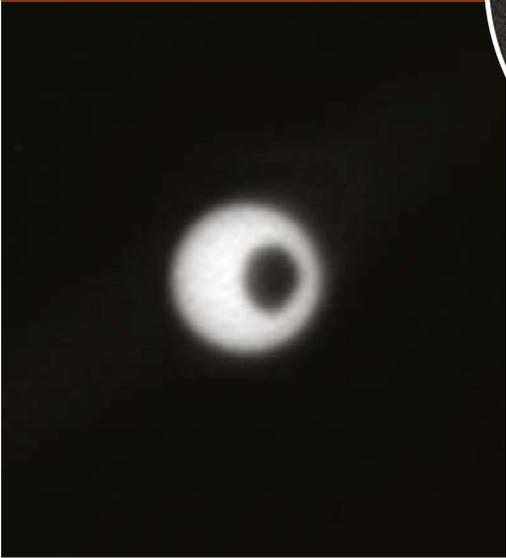
3809 Sols

Snaps of a close comet encounter

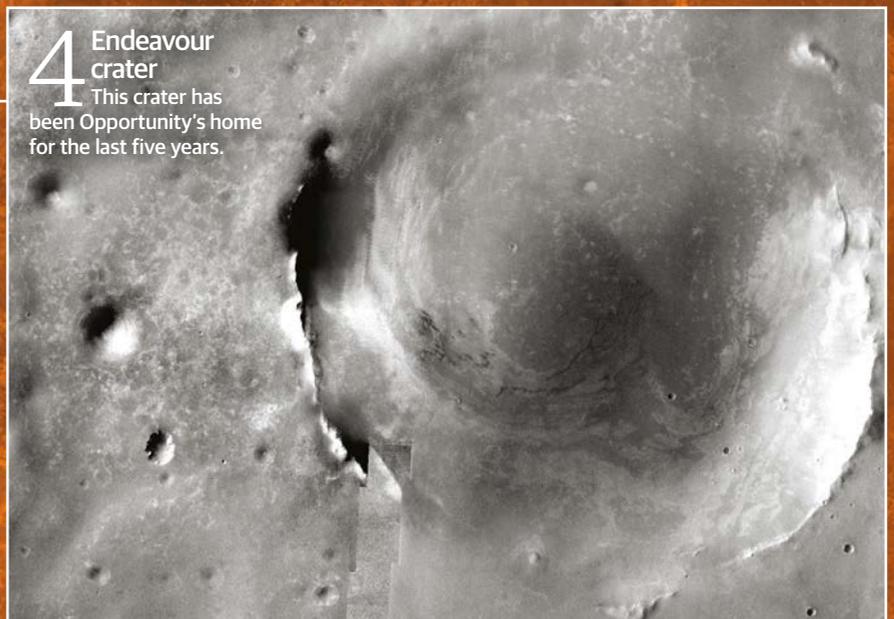
4 Endeavour crater

This crater has been Opportunity's home for the last five years.

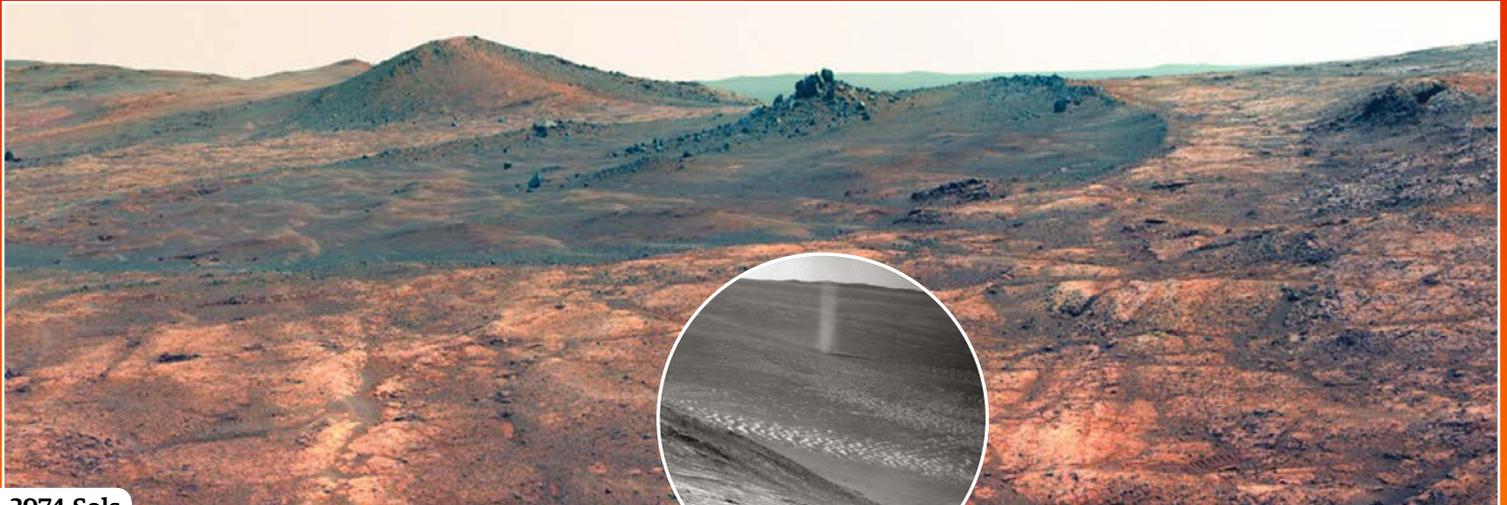
3974 Sols

Spirit of St Louis

This panoramic image from Opportunity shows the elongated crater known as "Spirit of St Louis." Towards the centre is a spire of rock stretching upwards towards the Martian sky. The crater is 34 metres (112 foot) long and about 24 metres (79 foot) wide. The spire of rock is thought to be between two and three metres (6.6 and 9.8 foot) tall, meaning it sits slightly higher than the rim of the crater. The image was taken in late March 2015, around the time Opportunity was celebrating its 4,000th Martian day.

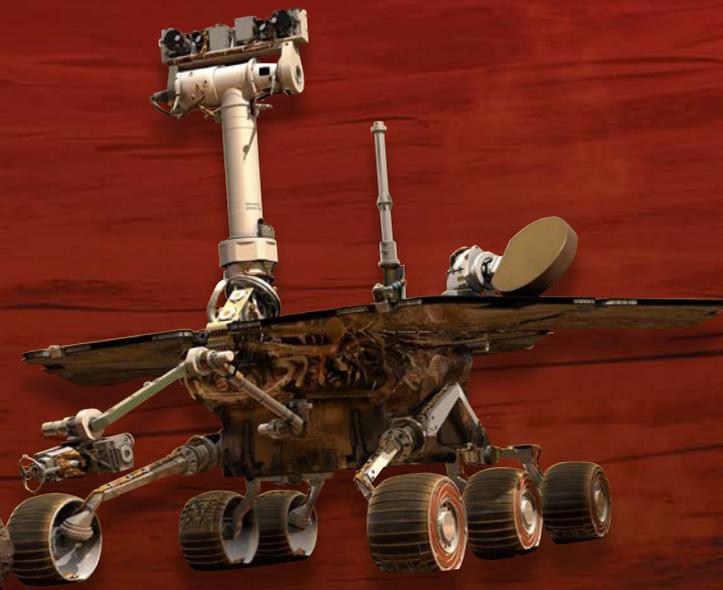
The anatomy of Opportunity

The equipment that helped Opportunity (and us) see the Red Planet

NavCam

A pair of black and white cameras mounted on the mast of the rover helped scientists to see the rover's surroundings and plan out its route across Mars

PanCam

A pair of colour cameras enabled Opportunity to take panoramic images of the Martian surface. The resolution of the cameras was designed to mimic the human eye

PanCam calibration target

A sundial with different coloured corners and engraved with the message: "Two worlds one Sun." Engineers calibrated the PanCams by adjusting the image until the colours look as they should

High-gain antenna

This antenna could beam information in a particular direction, such as towards the Earth or at one of the flotilla of satellites in orbit around Mars

Low-gain antenna

This antenna could send and receive signals from all directions. Radio waves were sent to and from the rover by the orbiting satellites

Front HazCam

One of four black and white cameras, these HazCams could see for three to four metres (9.8 to 13.1 foot) around the rover and were used to look for obstacles

Solar arrays

These solar panels generated up to 140W of power for up to four hours per Martian day. The rover needed 100W to drive. Two rechargeable batteries provided backup power

In-situ instruments

Four scientific instruments were mounted on this front robotic arm, including a microscope for close-up views of rocks and an abrasion tool for scratching surfaces
